Dam ID: HI00028
Puu Ka Ele

Inspection No: _____
Date: 20 March 2006

STATE OF HAWAII - DLNR
VISUAL DAM SAFETY INSPECTION SHEET

Inspection Type: Visual Dam Safety Inspection

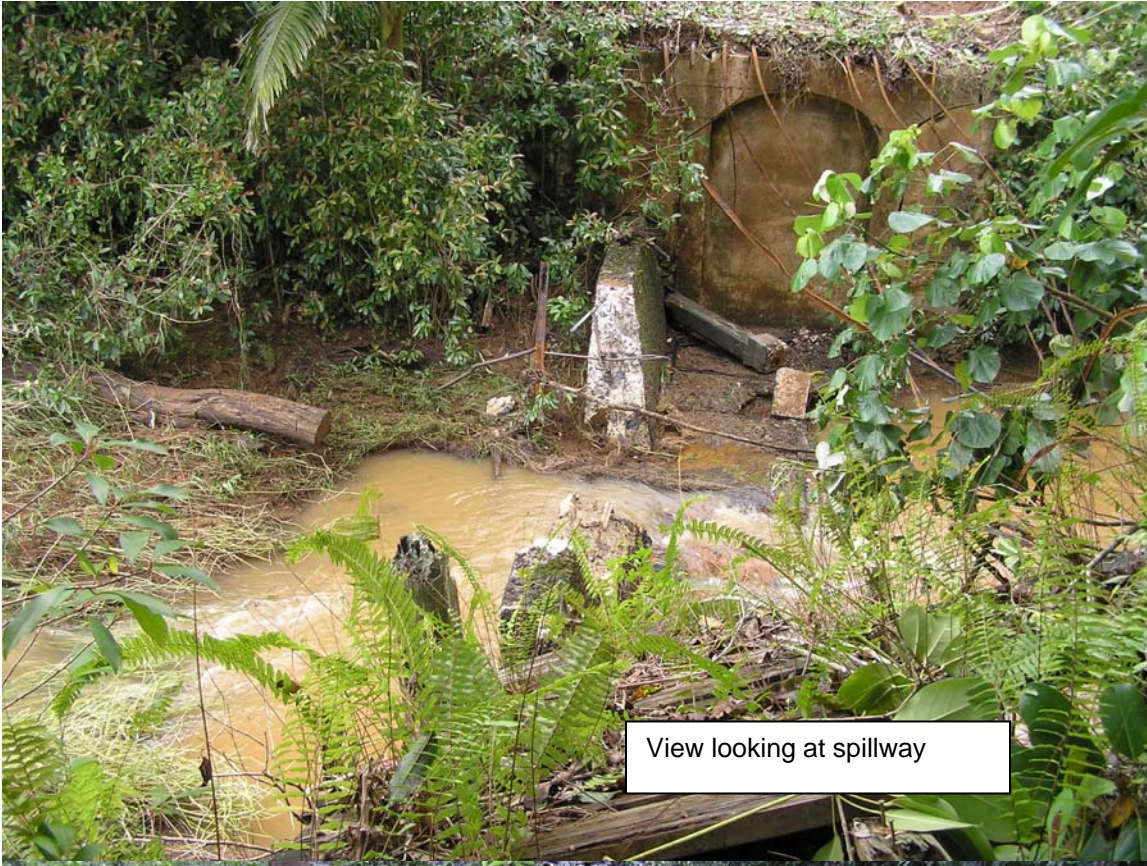
Type: ☐ None ☐ Culvert/Pipe ☒ Channel
Description: Gate removed, portions of concrete demolished.

Approach: ☐ Clear ☒ High Veg. ☐ Trees ☐ Other: _____

View looking at spillway

- ☐ d. Slope protection needs maintenance or repair. Description: _____
- ☒ e. The spillway approach was blocked. Clear approach.
- ☐ f. Severe scour erosion was observed which requires maintenance and/or repair.
Description: _____
- ☐ g. A headcut was observed downstream of the spillway. Corrective / mitigative action is required to prevent this problem from moving upstream.
- ☐ h. Trees are unacceptable in the spillway channel and approach. Take corrective action to address the woody vegetation problem and repair the damaged area.
- ☒ i. Unclear if spillway is adequately sized. Spillway should pass the probable maximum flood. Verify spillway capacity and take corrective action as required.
- ☐ j. _____

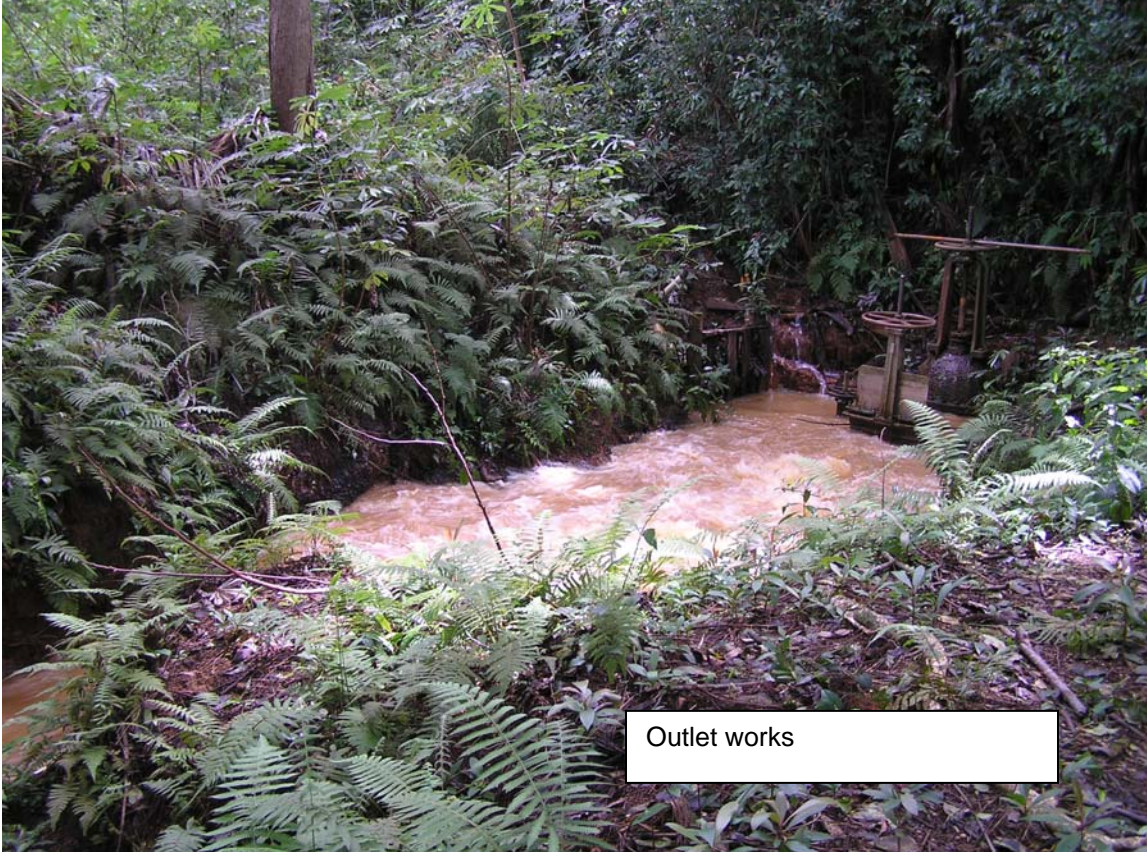
Type / Size: 24" gate valve, cut rock

- ☐ a. The outlet works were not inspected.
- ☐ b. The outlet works were not tested.
- ☐ c. The outlet works appeared to be in satisfactory condition, no corrective actions are required at this time.
- ☒ d. The outlet works appeared to be in fair to poor condition and requires corrective action.
- ☐ e. The outlet works appeared to be in unsatisfactory condition and not expected to fulfill its intended function. Urgent corrective action is required.

Outlet works

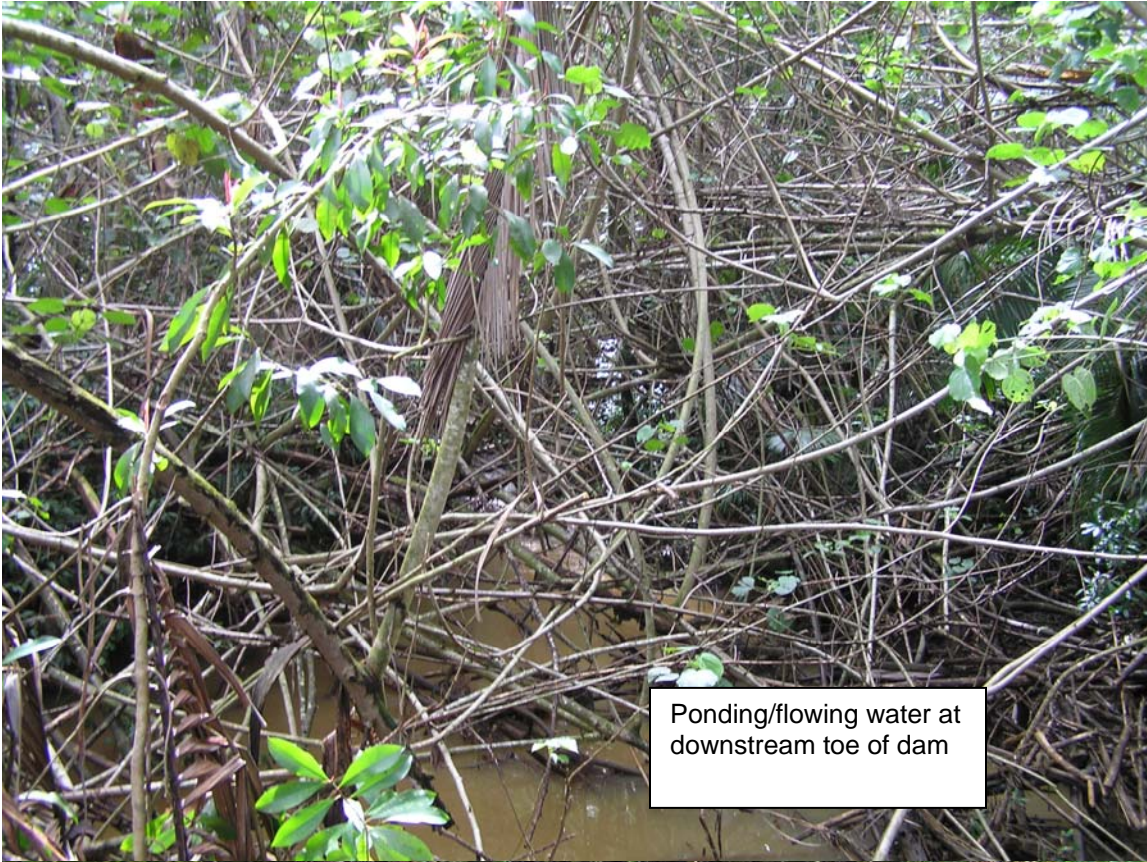
Seepage: ☐ Green Vegetation ☐ Wet or Muddy Ground ☒ Ponding Water ☒ Not Visible ☐ None Observed

Flowing, Description: Through the downstream channel berms.

Water Clarity: ☐ Clear ☐ Some particles ☒ Muddy ☐ Other: _____

Ponding/flowing water at downstream toe of dam

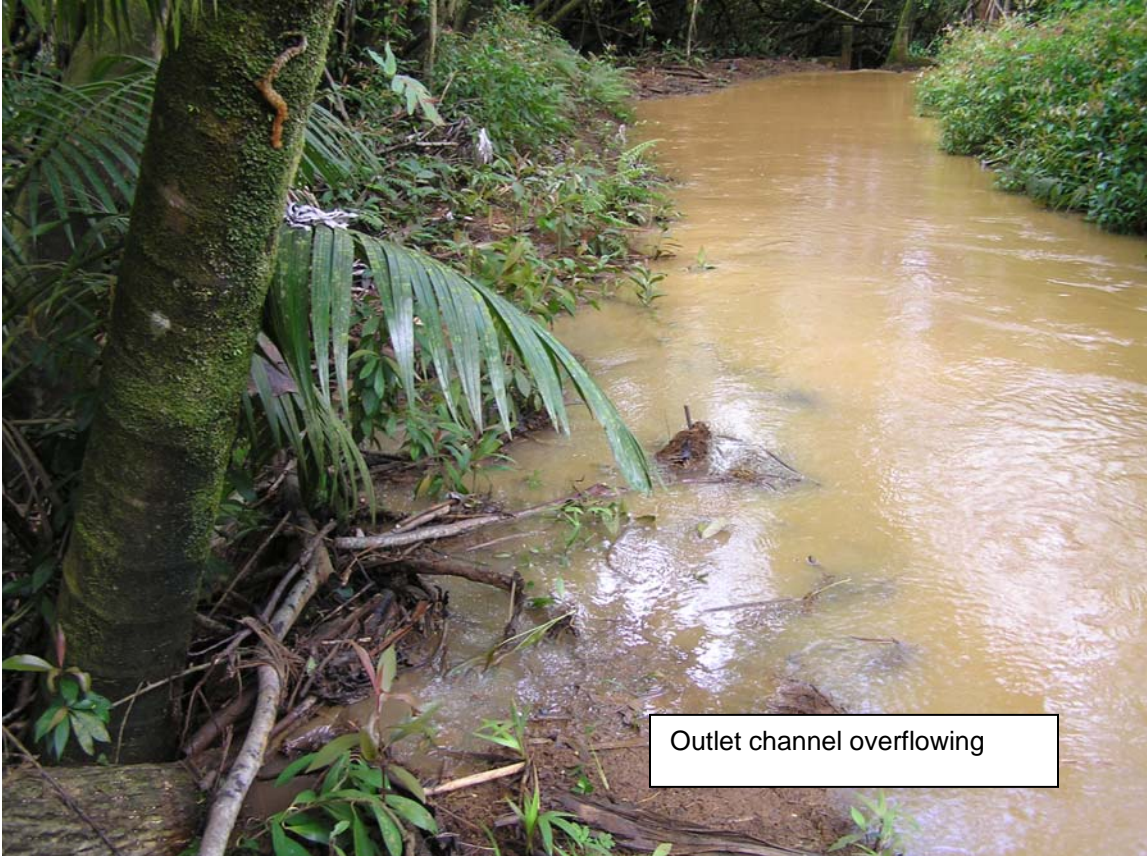
Channel berm downstream of the outlet was being overtopped. Decrease flow into channel or fill berm low spots.

Outlet channel overflowing
